Confidential Property Inspection Report

**Northern Waters Inspections and Testing LLC.
Jerry Kramer(Owner) License # 3414-106**

**Inspection Prepared For: John Smith
Agent: No Agent Used
Date of Inspection: August 4th, 2021
Property Address:
16435 W Oriole Lane Birchwood, WI**

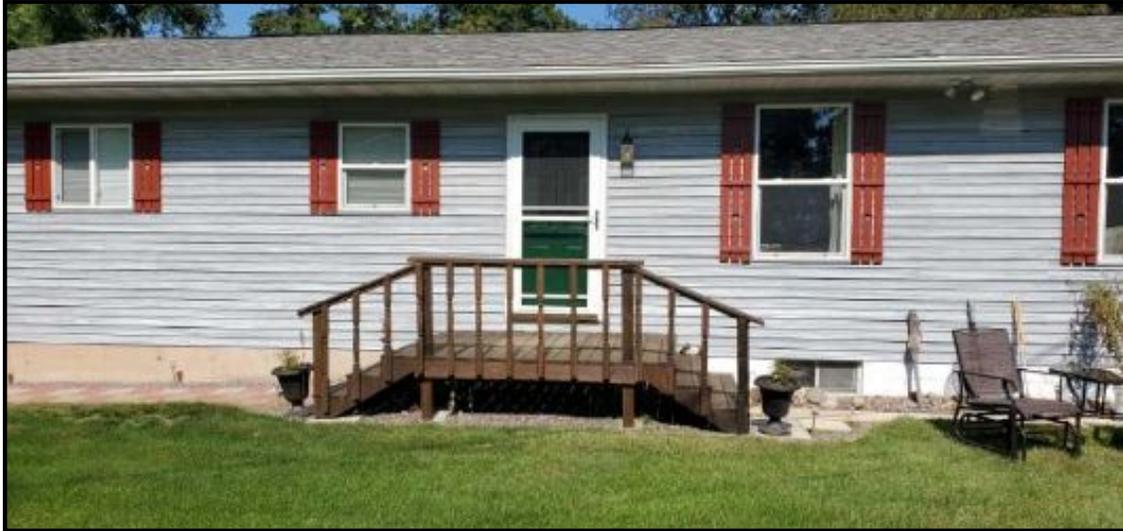
- Appears in satisfactory and functional condition with normal wear for its age.

Neither deck is attached to structure.
Free standing on 4x4 on concrete footing

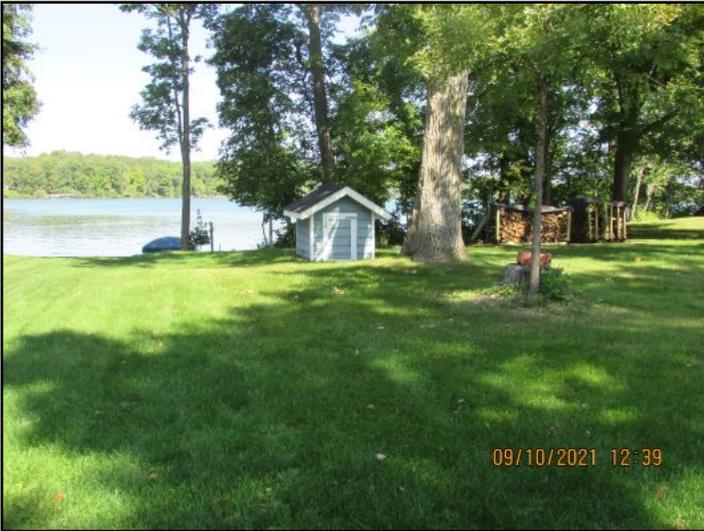
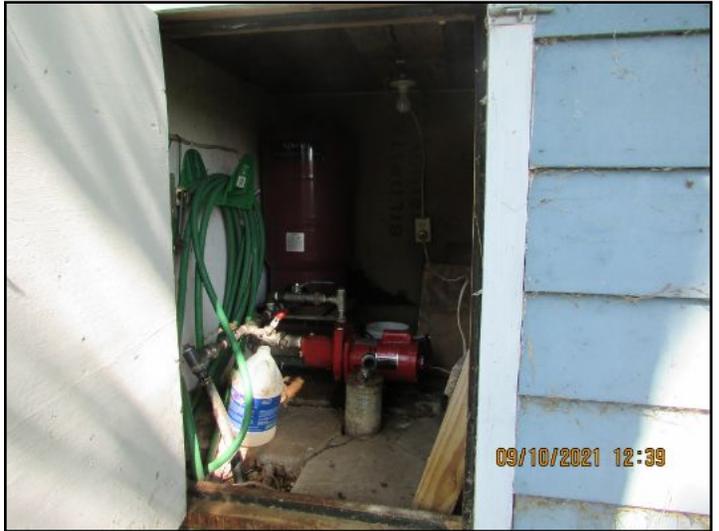
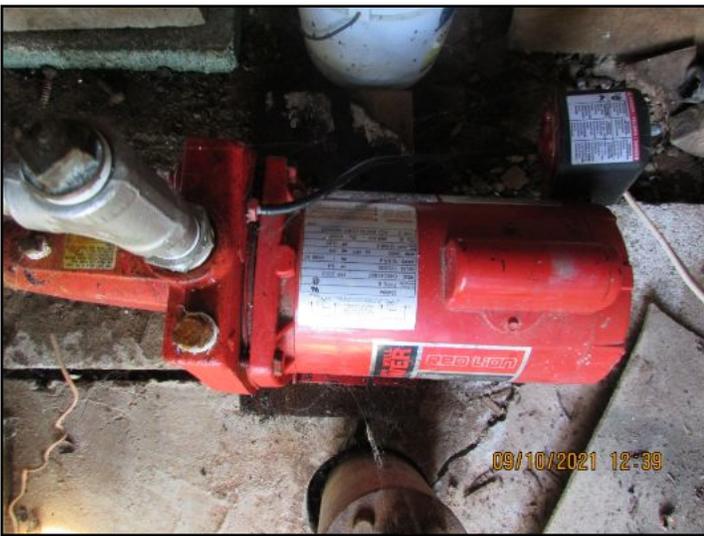
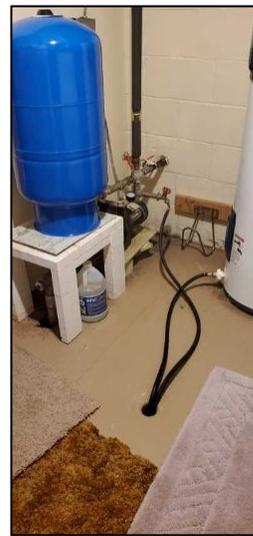
- Potable water supplied by well. There are TWO wells on the property. One is located in a pump house in yard and one is located in the basement. One looks to be used in the summer and one in the winter. Suggest water testing within inspection contingency period of BOTH wells.

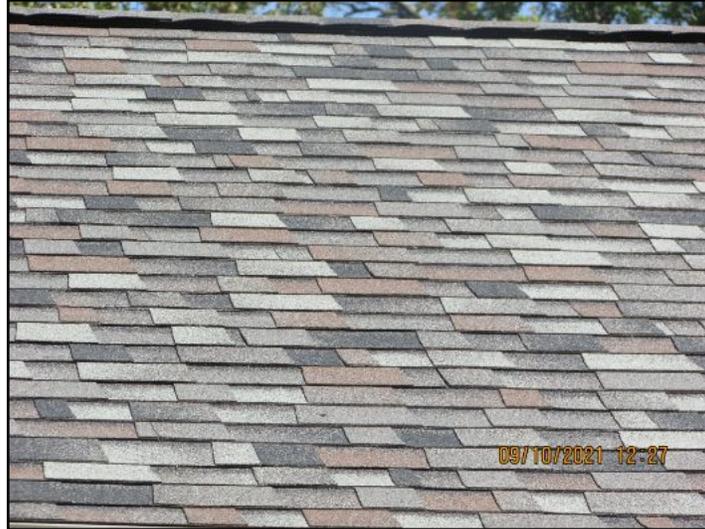
- No major system safety or function concerns noted at time of inspection. Shingles look to be recently replaced and at the beginning of their life.

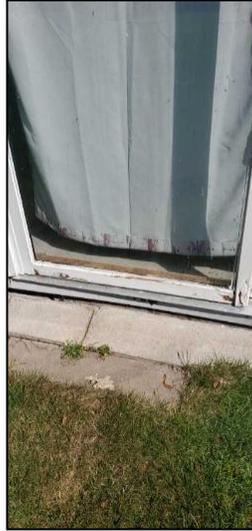
- None of the observed outlets at the garage were GFCI protected. This may have not been code at the time of the construction but, For safety, garage outlets should upgraded to GFCI protection

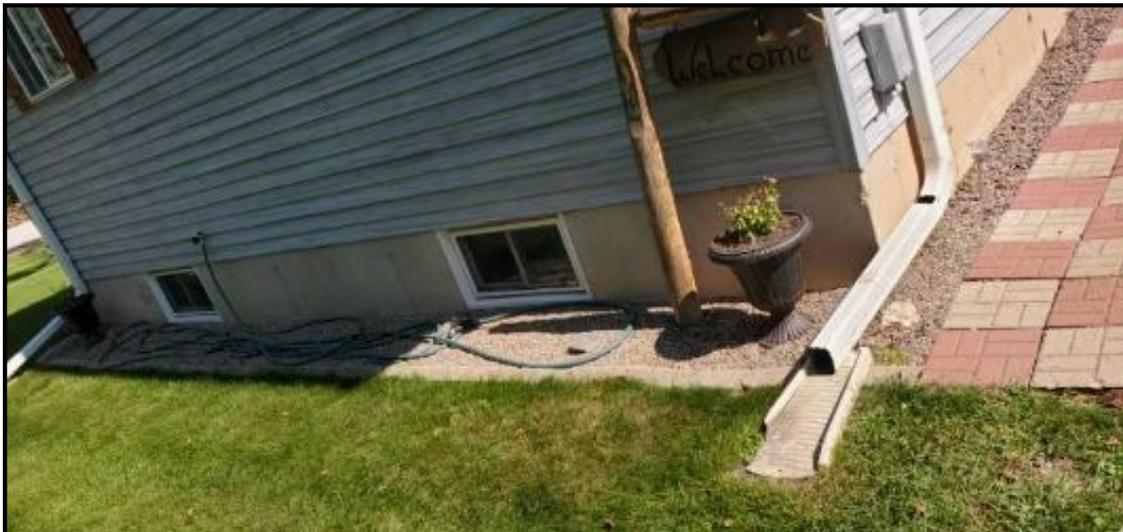
Gutters drain away from building with extension and splashblocks

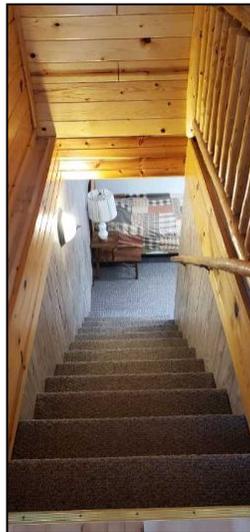
- Stairs to basement are functional but have 5' 8" headroom, which is lower than today's standards. This may or may not be an issue to occupants but should be noted.

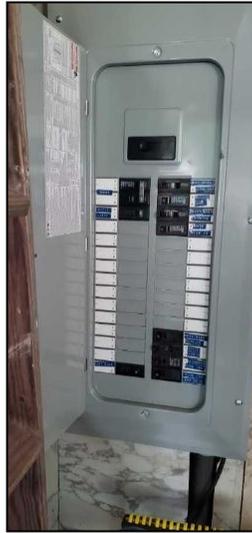
- 200 amp

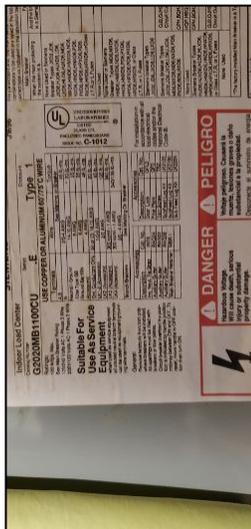
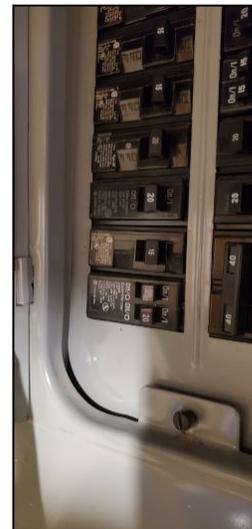
- All of the circuit breakers appeared serviceable. However, the panel in the basement of the home is not rated for use of "tandem" breakers but there are a couple tandem breakers in the panel. The breakers show no signs of overheating and were observed to be functioning as intended. Since the panel is not rated for their use, it is recommended that an electrician review and update where necessary.

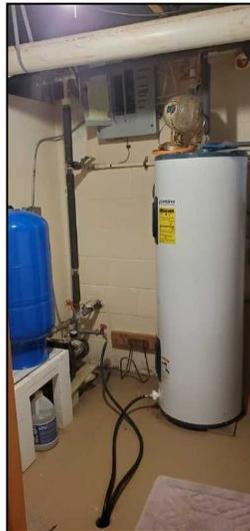
- The water heater is functional and operating as intended. Water heater manufactured in 2006. Recommend budgeting for replacement in future as service life can vary, with "average" life expectancy around 10 to 15 years.

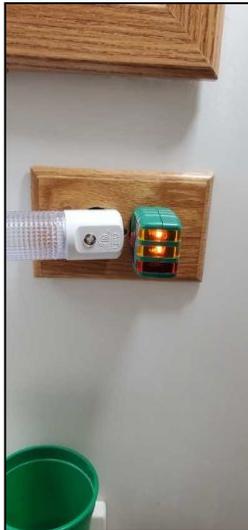
- No GFCI protection present, at the vanity outlet. Recommend installing GFCI protected receptacle for safety.

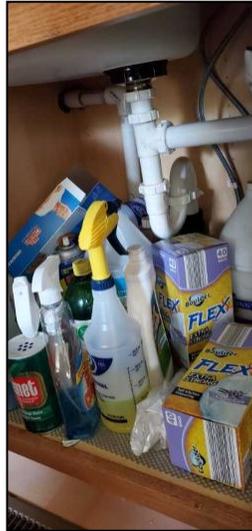
- Improper "S" trap noted. This trap configuration may cause the trap to siphon dry, allowing sewer gas and odor to enter the dwelling. This situation may be rectified by the installation of an anti siphon device (cheater vent). Suggest repair by a qualified professional. Until addressed, run water into the sink to reseal the trap if odor is detected.
